File No. EA2021-135

CITY OF RICHLAND
Determination of Non-Significance

PLAN VIEW FOR GRADING PERMIT: 21-02601 - 4608 E 210 PR NE
SECTION 20, T9N, R28E of the W.M. - (CONTOUR INTERVAL = 2 FEET)

GEOTECHNICAL EVALUATION AND CRITICAL AREAS ASSESSMENT REPORT

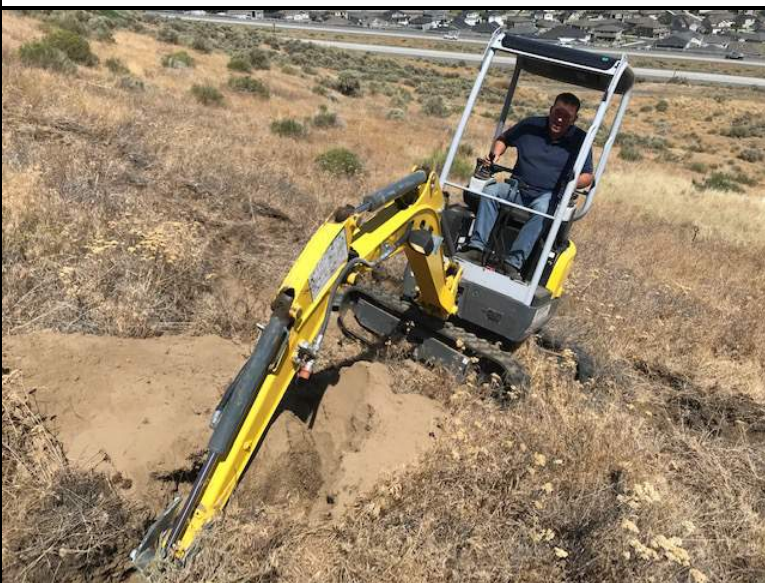
Excavation of test pit TP-3 looking NW

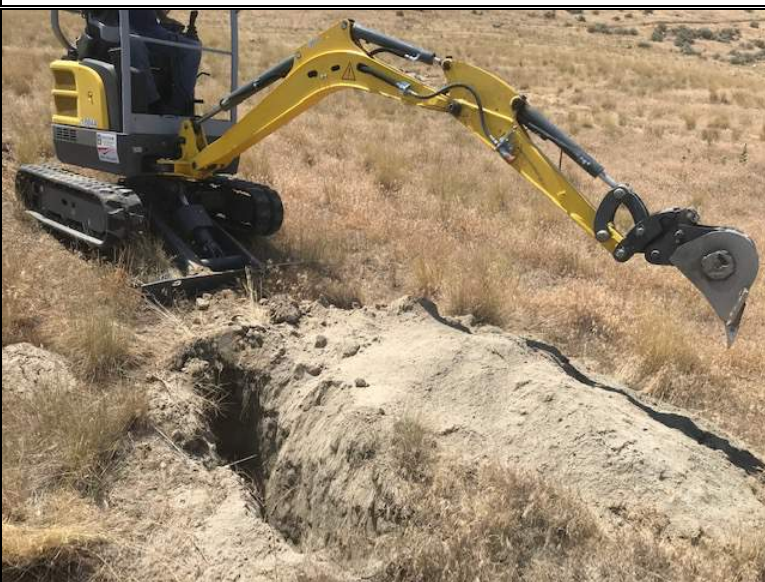
Excavation of test pit TP-7 looking west
